# Manhole Inspection Summary

Manhole # S19E\_\_035MH

**Location** Address: **325 PAYSON ST** Cross Street: **MULBERRY ST**

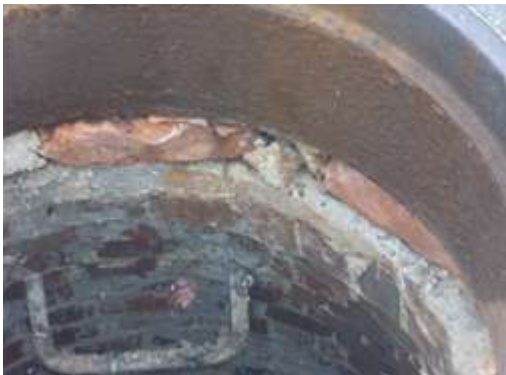
Defect 3

**Chimney / Frame Adjustment** ☒ Exists Material: **Brick** ☐ Parged Height: **3** (in.)  
Condition: ☐ Sound ☐ Cracked ☐ Root Intrusion ☐ Loose Brick ☒ **Deteriorated**  
Infiltration: ☒ None ☐ Joint ☐ Cracks ☐ Mortar ☐ Roots ☐ Wall

CHIMNEY DETERIORATION

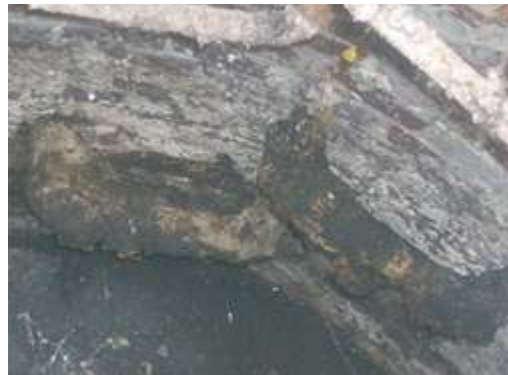
Defect 2

**Surcharge** ☒ **Evidence Of Surcharge** Depth: **3** (ft.) ☐ Active Surcharge Present

SURCHARGE EVIDENCE ON STEPS

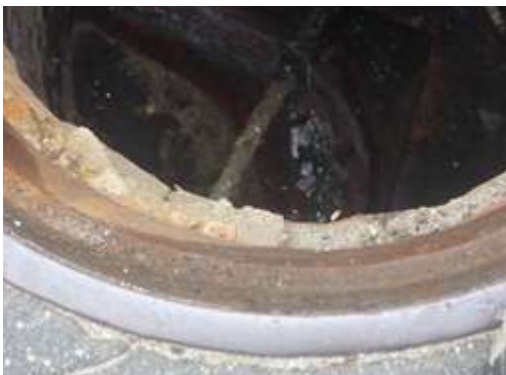
Defect 1

**Frame** Offset: **1** (in.) Condition: ☒ Sound ☐ Cracked ☐ Leaks

FRAME OFFSET

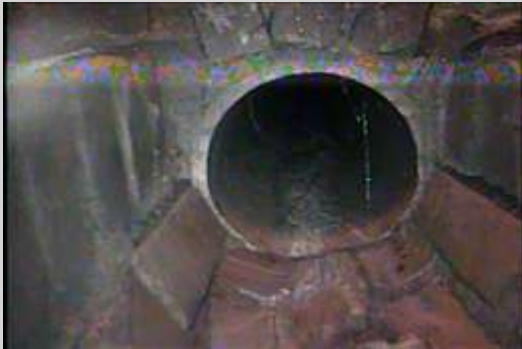
12 O'Clock Outflow

8 in. Circular Gravity Sewer  
Pipe Out @ 12 O'Clock

Pipe Height: **7.2** (in.) Rod and Bar (Angled)  
Pipe Material: **Clay** ☐ Pipe Lined  
Invert Depth: **8.77** (ft.) Flow Characteristics: **Fast**  
Deposits: ☒ None ☐ Mud ☐ Sludge ☐ Debris ☐ Grease  
Silt Depth: (in.) Deposits Extent:  
Infiltration: **None** Pipe Seal Cond: **Sound**

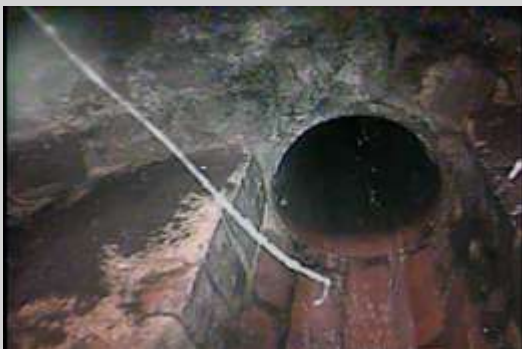
3 O'Clock Inflow

8 in. Circular Gravity Sewer  
Pipe In @ 3 O'Clock

Pipe Height: **8.4** (in.) Rod and Bar (Angled)  
Pipe Material: **Clay** ☐ Pipe Lined  
Invert Depth: **8.33** (ft.) Flow Characteristics: **Fast**  
Deposits: ☒ None ☐ Mud ☐ Sludge ☐ Debris ☐ Grease  
Silt Depth: (in.) Deposits Extent:  
Infiltration: **None** Pipe Seal Cond: **Sound**
